Beach Profile Changes : East Coast of Lake Michigan, 1970-72

by
R.A. Davis, W.G. Fingleton, and P.C. Pritchett

MISCELLANEOUS PAPER NO. 10-75
OCTOBER 1975

Prepared for
U.S. ARMY, CORPS OF ENGINEERS
COASTAL ENGINEERING
RESEARCH CENTER

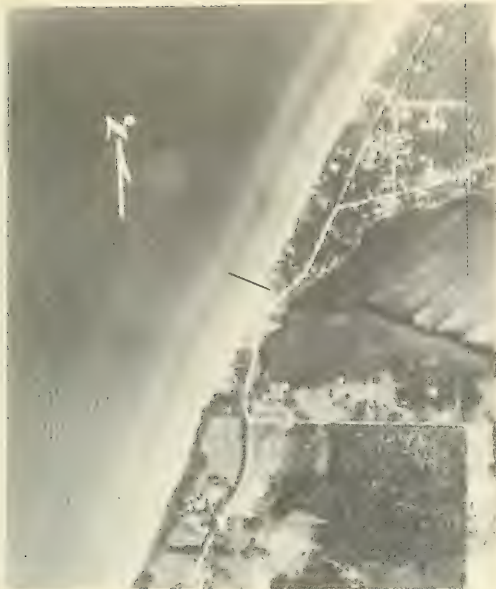
Geomorphology. Site is adjacent to Bar Lake in Manistee County. Shoreline orientation is N.27°E. Beach is bounded by a terrace of beach and dune sands that rises 10 to 20 feet above the lake. Sediment is mostly sand. Scattered fine gravel sometimes is present in the plunge zone only.

Figure 8. Location and geomorphology of profile site 3.

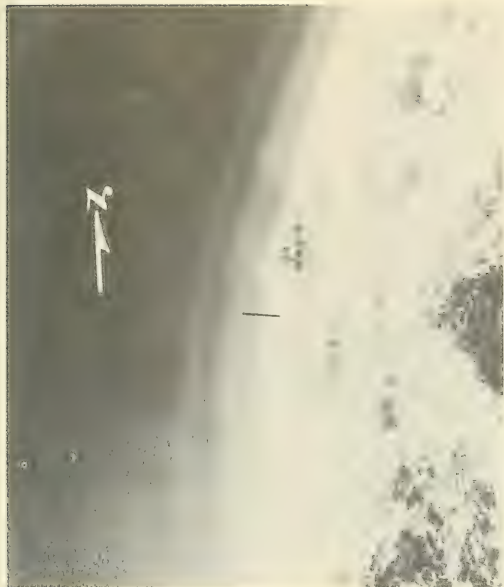
Geomorphology. Beach at Big Sable Point has a shoreline orientation of $N.7^{\circ}E$. This part of the eastern Lake Michigan coast is one of the most extensive dune areas. Dunes extend several miles in either direction from Big Sable Point and a few miles inland at the point. Dunes are covered with grass and small bushes. Virtually no gravel was found, reflecting the proximity to dunes.

Figure 9. Location and geomorphology of profile site 4.

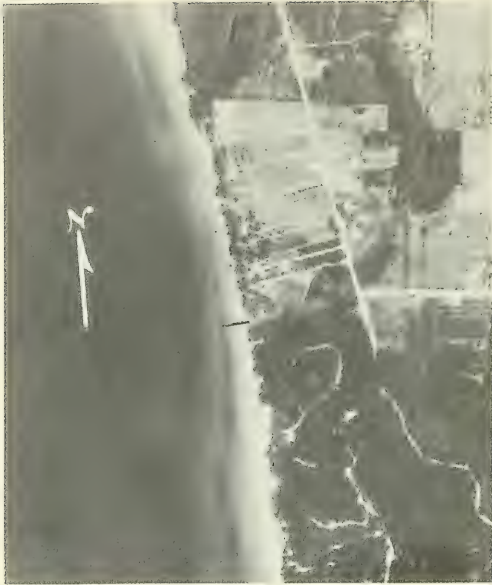
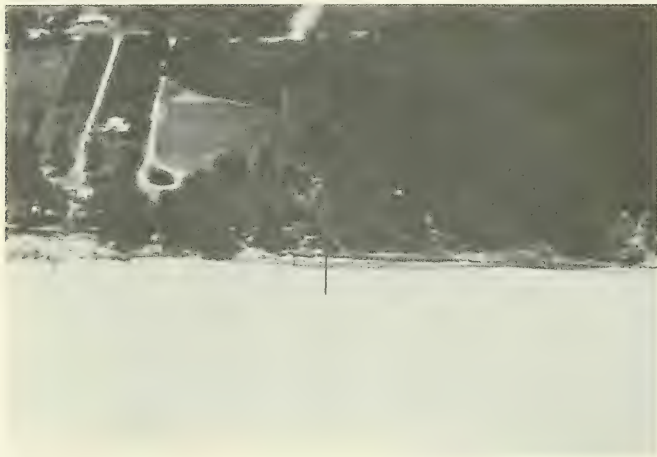
Geomorphology. Beach at Summit Township Park (Mason County) has a shoreline orientation of N.7°W. and is adjacent to bluffs of glacial drift. At times, glacial till was observed cropping out just lakeward of the plunge step. Foreshore comprised of well-sorted and rounded cobbles. Large percentage of the sand in backshore is from a sand terrace where the upper swash of waves has undercut the terrace and vertical slope has failed.

Figure 10. Location and geomorphology of profile site 5.

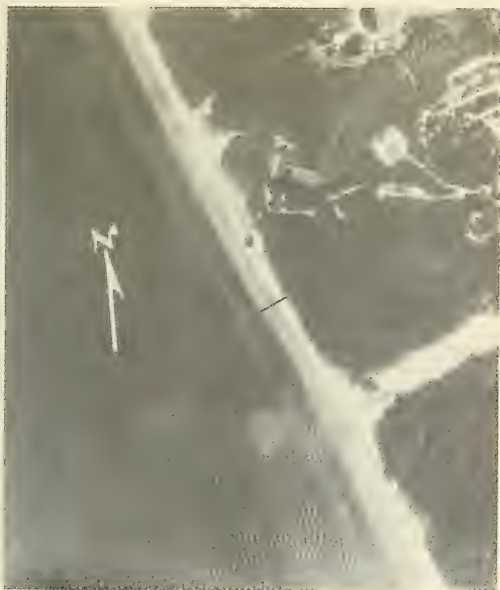
Geomorphology At P.J. Hoffmaster State Park in Muskegon County; shore-line orientation is N.25°W. Coastal morphology is comprised of large stabilized dunes with mature trees. Between dunes and beach is a broad foredune terrace which is grass-covered. Beach and nearshore zone are typically medium, well-sorted sand.

Figure 14. Location and geomorphology of profile site 9.

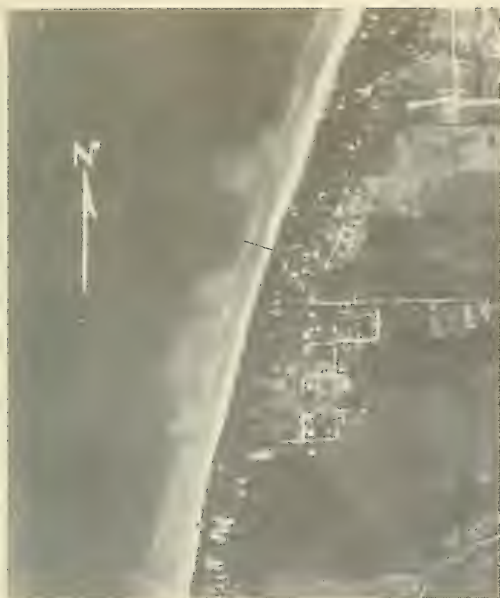
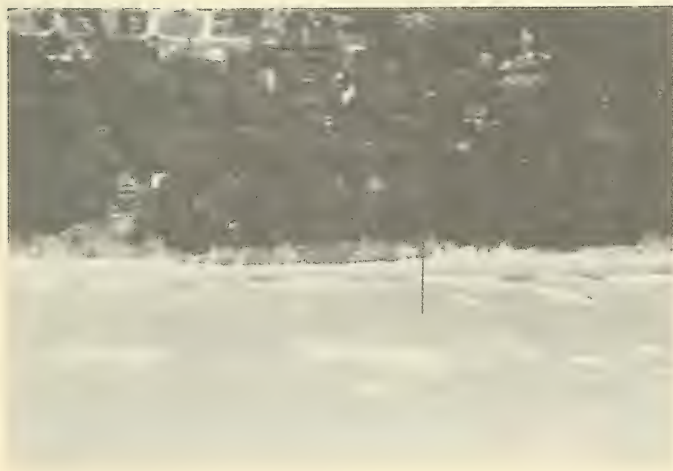
Geomorphology. Public beach at Douglas, Michigan, has a shoreline orientation that trends N.16°E. Stabilized dunes are present with a typical foredune terrace covered by grass. High bluffs of glacial till a few miles to the south.

Figure 17. Location and geomorphology of profile site 12.

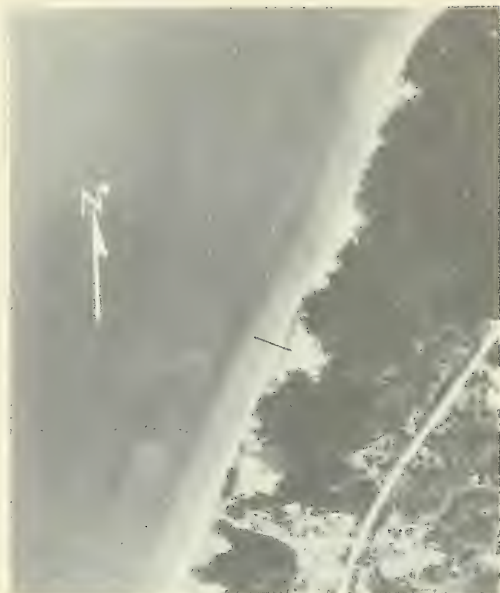
Geomorphology. The Van Buren State Park site is located at the base of a large blowout in vegetated dunes that rise about 150 feet above lake level and are among the largest along the eastern Lake Michigan coast. Shoreline orientation is N.25°E. Top of a thick Pleistocene peat bed, exposed in a steeply inclined terrace at the upper margin of the beach, has been dated at 4,000 B.P. (Zumberge and Potzer, 1956). During a 1969 summer storm, glacial till was exposed in the nearshore zone just lakeward of the plunge step; not known to be exposed during the present study.

Figure 19. Location and geomorphology of profile site 14.

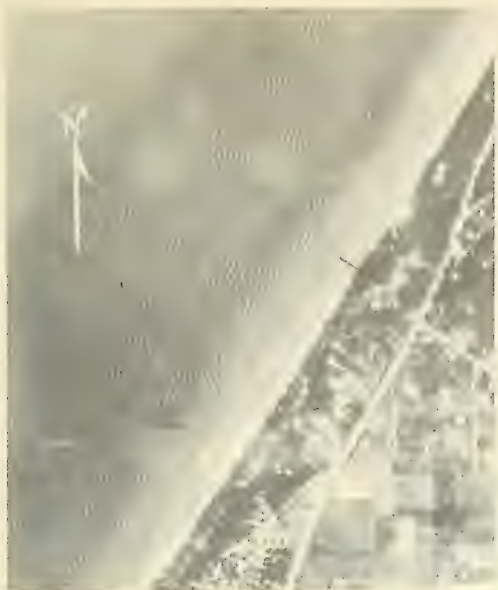
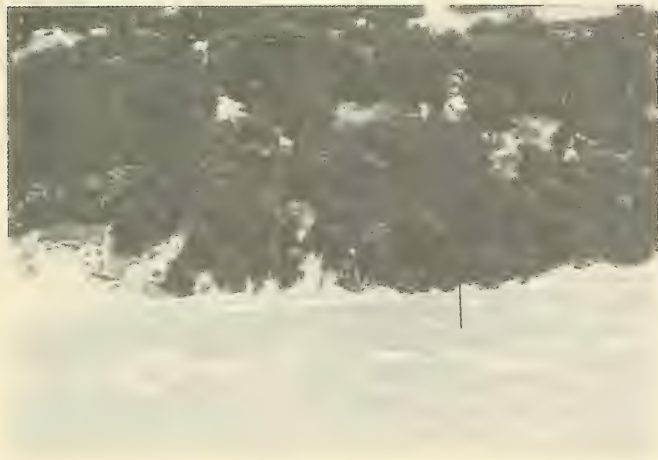
Geomorphology. Site has a shoreline orientation of N.34°E. Profile is adjacent to bluffs of glacial till at the Hagar Township Park (Berrien County). Bluffs rise about 35 feet above the lake and continue for 1 mile or more in either direction. Bluffs are probably stable as they are covered with fairly mature trees and shrubs.

Figure 20. Location and geomorphology of profile site 15.

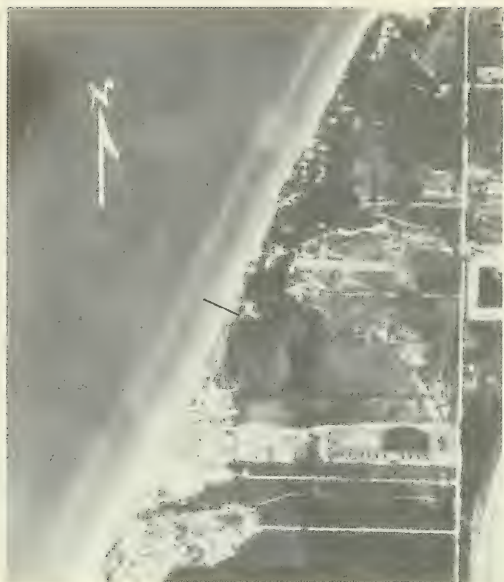
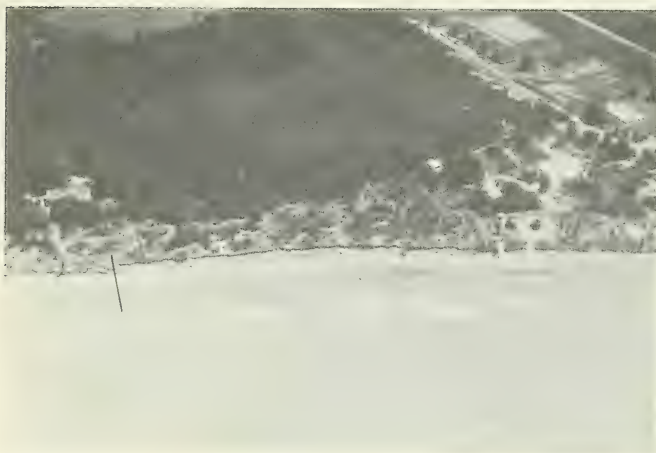
Geomorphology. Beach at Stevensville, Michigan, has a shoreline orientation of $N.28^{\circ}E.$ and is the site of the time-series study by Fox and Davis (1970a, b). Fore-dune terrace is adjacent to small vegetated dunes. One mile or more to the north (updrift) is an extensive stretch of high bluffs of glacial till.

Figure 21. Location and geomorphology of profile site 16.

This site (Fig. 21) was also stable with the exception of a few feet of erosion during the first study year. The bluff receded 4 feet in the late fall of 1970 and 1 foot the following spring. No erosion occurred during the second year. This site was investigated in great detail during a time-series study in the summer of 1969 (Fox and Davis, 1970a). Most of the bluff erosion took place during a severe summer storm (Fox and Davis, 1970b) and the fall storm period. Total recession during the last half of 1969 was 25 feet. Stability has prevailed since that time, however, despite the high energy conditions that occurred in the fall of 1970 and 1971. Erosion was pronounced in adjacent areas during both years.

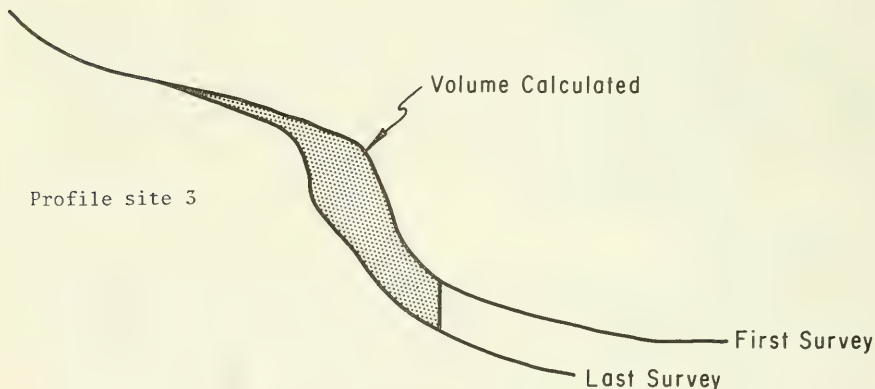
Figure 25. Example of eroded volume computation.

The volume of material removed from the dunes or bluffs was estimated during each year of the 2-year study. These values were computed by overlaying the first and last surveys for a study year, locating the intersection of the beach with the bluff on the first survey, dropping a vertical line from that intersection to the profile of the last survey, and then calculating the volume eroded landward of that vertical line. The resulting volume is shown two-dimensionally in Figure 25. The composition of the bluff (sand or till) and the volume eroded for each year are shown in Table 6. The pattern of erosion is presented in Section V, Profile Descriptions; volumes calculated range from 0 to 19.9 cubic yards per foot of beach front per year. Data on the size distribution of eroded material were not collected.

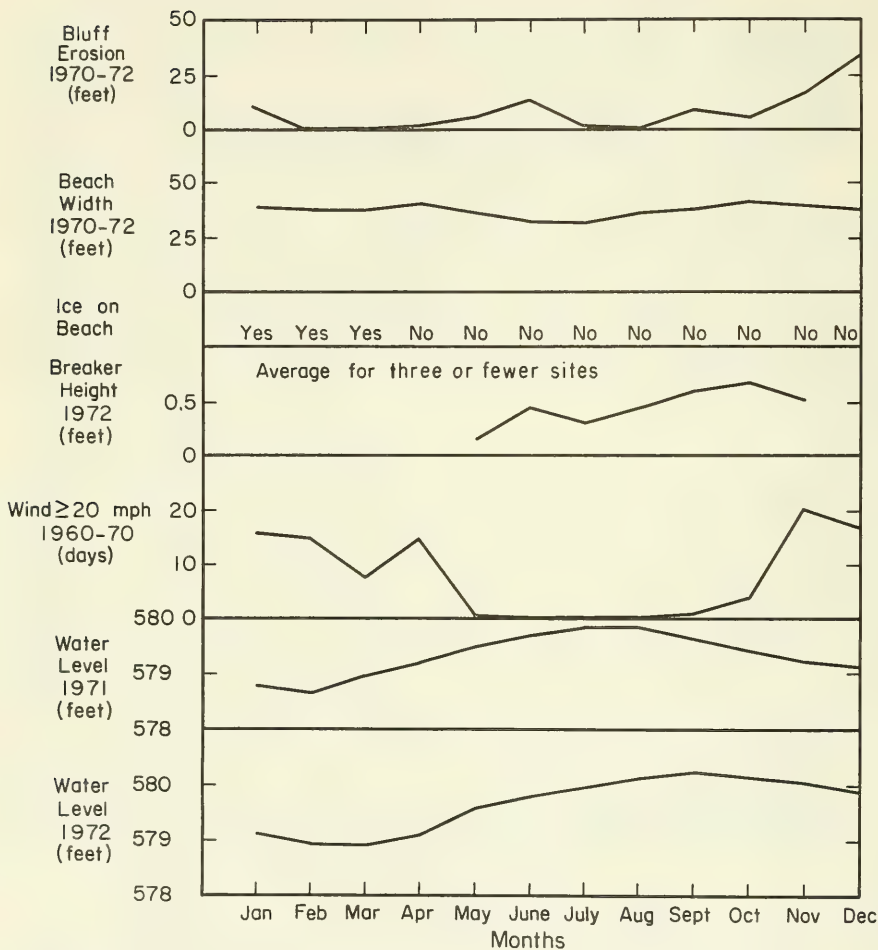
Figure 27. Mean monthly values of Lake Michigan environmental variables (wind data from Seibel, 1972).

- (a) Mean monthly values of bluff erosion, beach width, breaker height, wind, and lake level are given in Figure 27. In this 2-year period, lake levels were rising from a mean annual value of 578.93 feet above mean water line (MWL) in 1970 to 579.66 feet MWL in 1972. The rise resulted in narrow beaches without berms and easy access, by waves, to the foredune

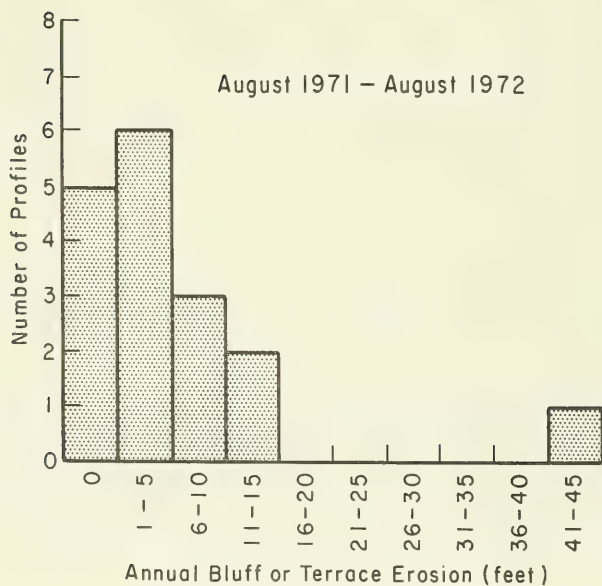
Figure 28. Distribution of yearly erosion.
